TS 0524 – CCTV Inspection of Gravity Sewer Infrastructure

Version: 2.3

Document ID: SAWS-ENG-0524

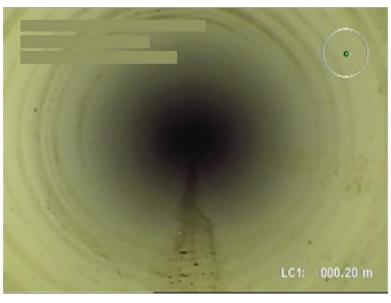
Figure 1 Example of poor quality image

- of poor resolution,
- out of focus, or.
- displaying inadequate lighting
- camera moving too fast, not allowing sufficient assement

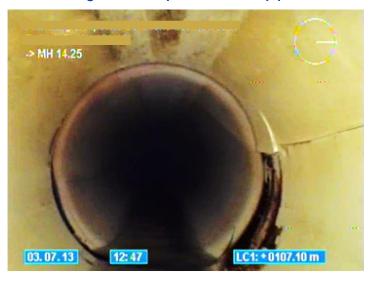
Figure 2 Example of cracked pipe

SA Water will not accept any crack in a new or recently constructed pipe or structure.

Longitudinal or circumferential cracks will shorten the asset life of the pipe and will provide the opportunity for root, groundwater, or soil intrusion. Cracks may also result in external release of sewage which is in breach of environmental protection legislation.

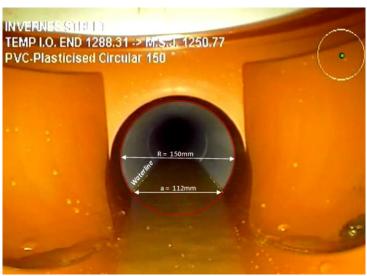
Figure 7 Example of pooling

Backfall and the resultant ponding of water, may be due to the conduit being laid at an irregular grade or it may be due to a localised loss of foundation, or side support characterised by a dropped invert.

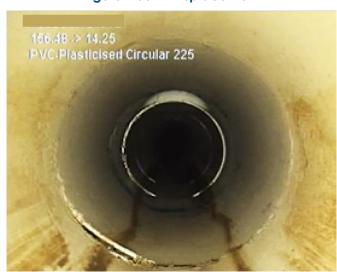
Figure 9 Joint Displacement

SA Water is concerned about immediate and ongoing issues and defects, as a result of unsatisfactory pipe jointing. Typical problems may be:

Examples of unsatisfactory joints are presented in Figures 9 to 11.
